RIVER AUX VASES BASIN
BUTTERFLY AND RAINBOW LAKES
STE. GENEVIEVE COUNTY, MISSOURI

MISSOURI INVENTORY NOS.
BUTTERFLY LAKE MO. 30501
RAINBOW LAKE MO. 30641

PHASE I INSPECTION REPORT
NATIONAL DAM SAFETY PROGRAM

SEPTEMBER 1978

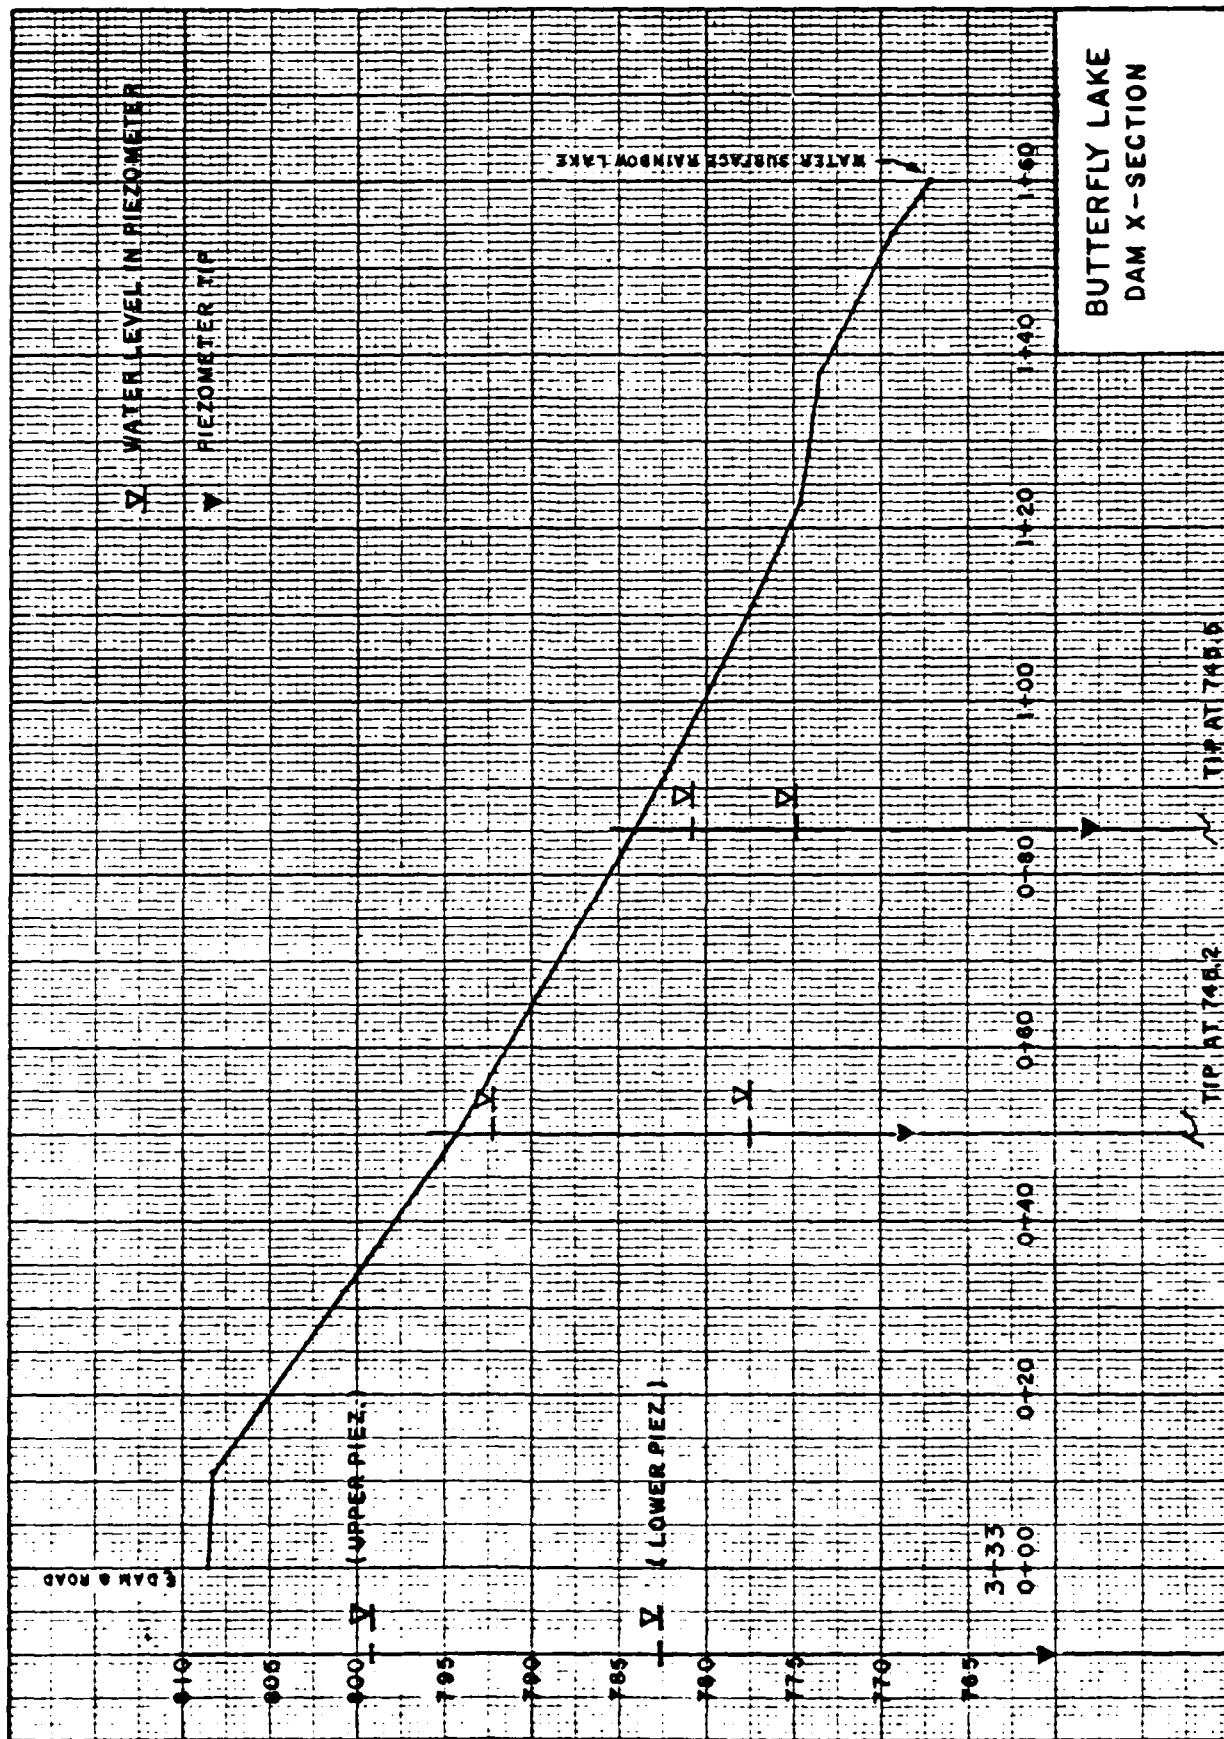
BUTTERFLY LAKE
DAM X-SECTION

c. Dams. No detrimental settlement, cracks, active slides or sinkholes were observed in or near the embankment. Embankment cross-sections near the maximum height section for each dam are shown on PLATES 3 and 4. These slopes are typical of the overall embankments. An old, healed slide is present on the downstream face of Butterfly Dam at the location of the surveyed section. The owner's engineer has installed 6 piezometers in this section and a row of horizontally aligned metal posts along the mid-slope to monitor movement.
